National Dam Inspection Program.
Griffin Dam (NDI PA-035, PA455),
Susquehanna River Basin, West Beechwood
Run, Tioga County, Pennsylvania. Phase
I Inspection Report.

PA-455 Dam (Griffin Dam): NDS I.D. No. PA-00035

Owner: Tioga County Commissioners
State Located: Pennsylvania (PennDER I.D. No. 59-62)
County Located: Tioga County
Stream: West Beech Woods Run
Inspection Date(s): 6 & 7 November 1978
Inspection Team: GAI Consultants, Inc.
570 Beatty Road
Monroeville, Pennsylvania 15146

PHASE I INSPECTION REPORT
NATIONAL DAM INSPECTION PROGRAM
PA-455 DAM (GRIFFIN DAM)
NDI# PA-035, PENNDER# 59-62

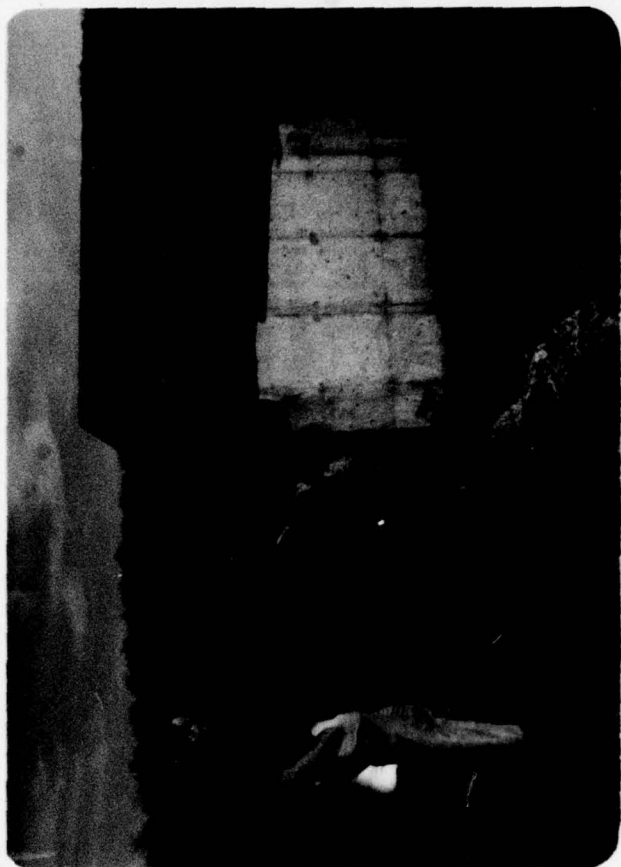
1. Service Spillway. The drop inlet, reinforced concrete riser appears to be in excellent condition. No cracks or signs of weathering were observed in either the interior or exterior of the structure (see Photographs 4 and 6). The trash rack attached to the upstream face of the riser did display areas of surface corrosion but is considered minor at this time (see Photograph 7).

PHOTOGRAPH 4 View of the service spillway riser.

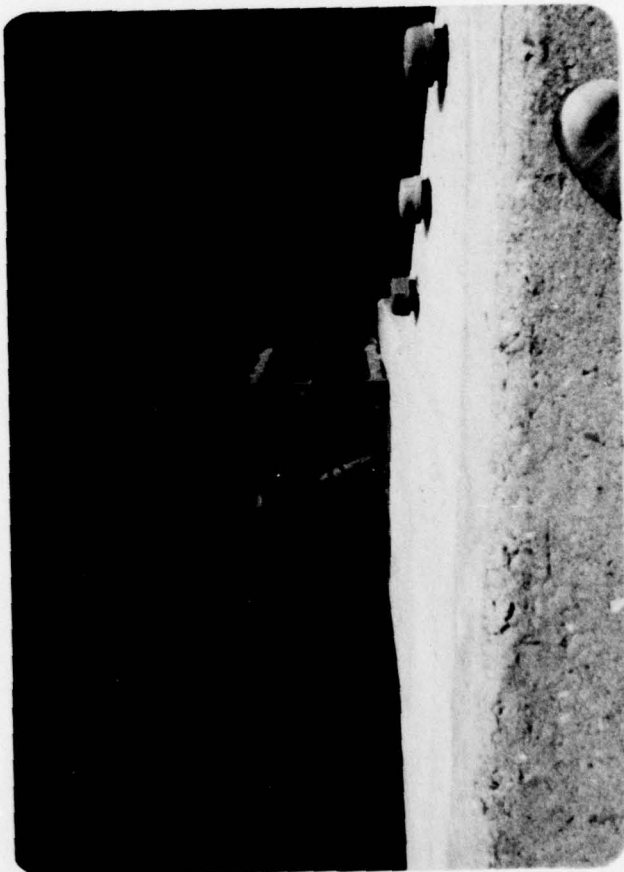
PHOTOGRAPH 7 View of the trash rack over the primary inlet located on the upstream face of the riser.

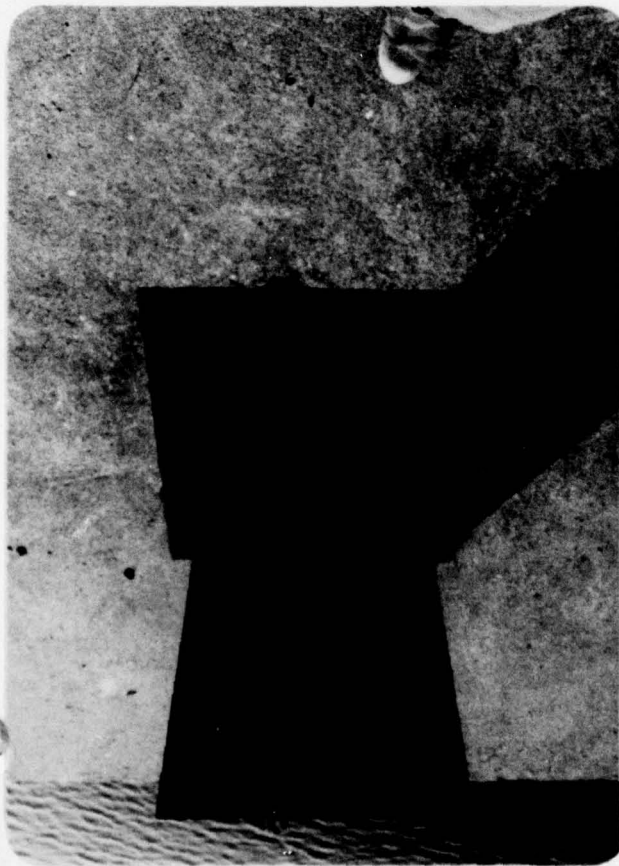
PHOTOGRAPH 5 View from atop the service spillway riser showing the access manhole.
